Washington State
School Seismic Safety Assessments Project

MARYSVILLE-PILCHUCK HIGH SCHOOL LIBRARY (BUILDING J) Marysville School District 25

SEISMIC UPGRADES CONCEPT DESIGN REPORT

June 2021

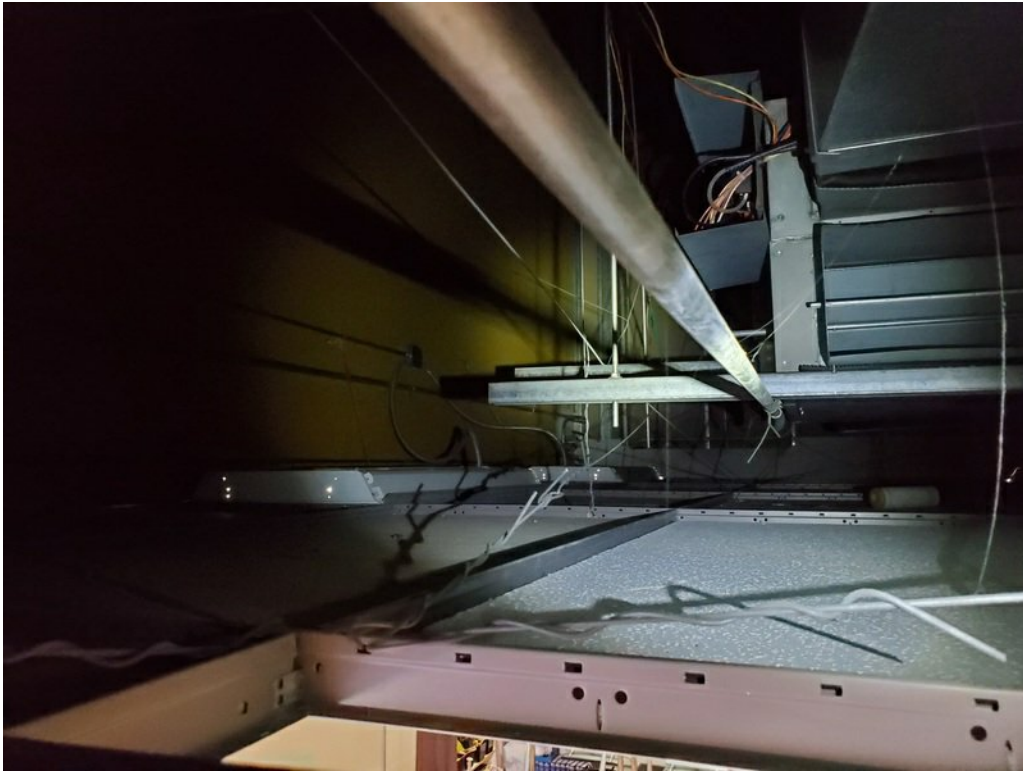
Figure 1-9. Building J, Light Fixtures Supported by Ceiling Grid
